Doctoral Dissertations

## Fracture Biomechanics of the Human Skeleton

Anne M. Kroman

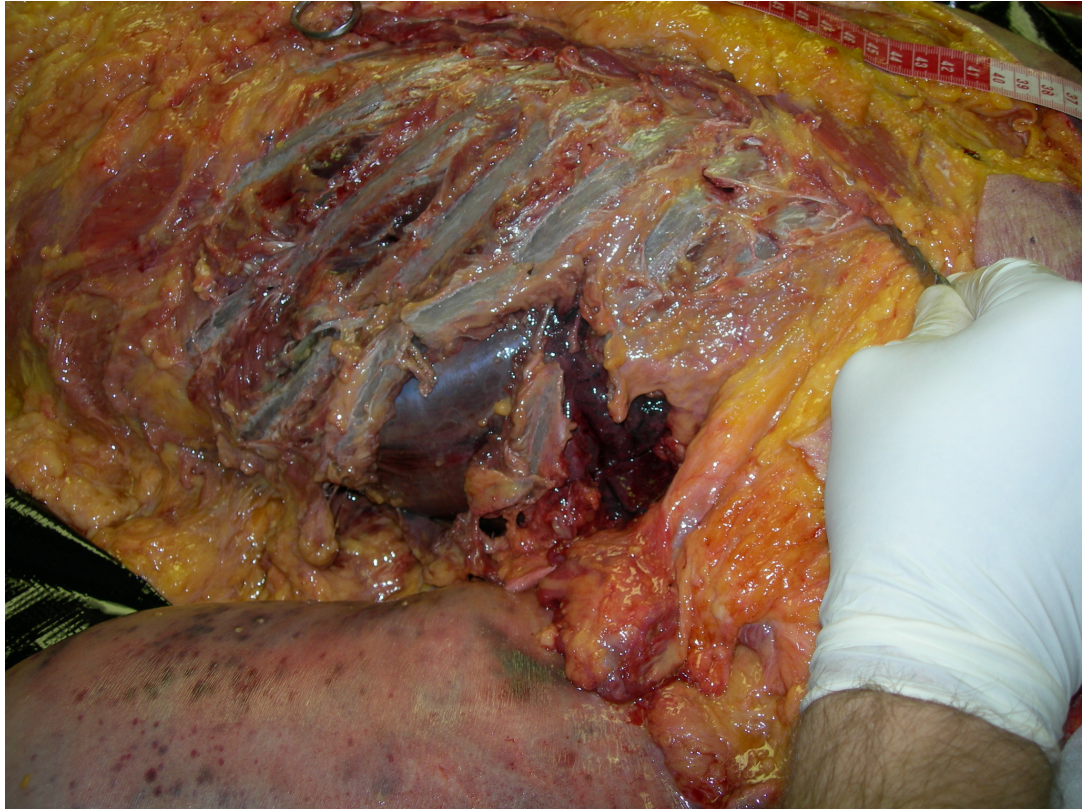
Figure 3.21 Multiple rib fractures and lacerated lung in human specimen 3 from test 14.H3S7R.

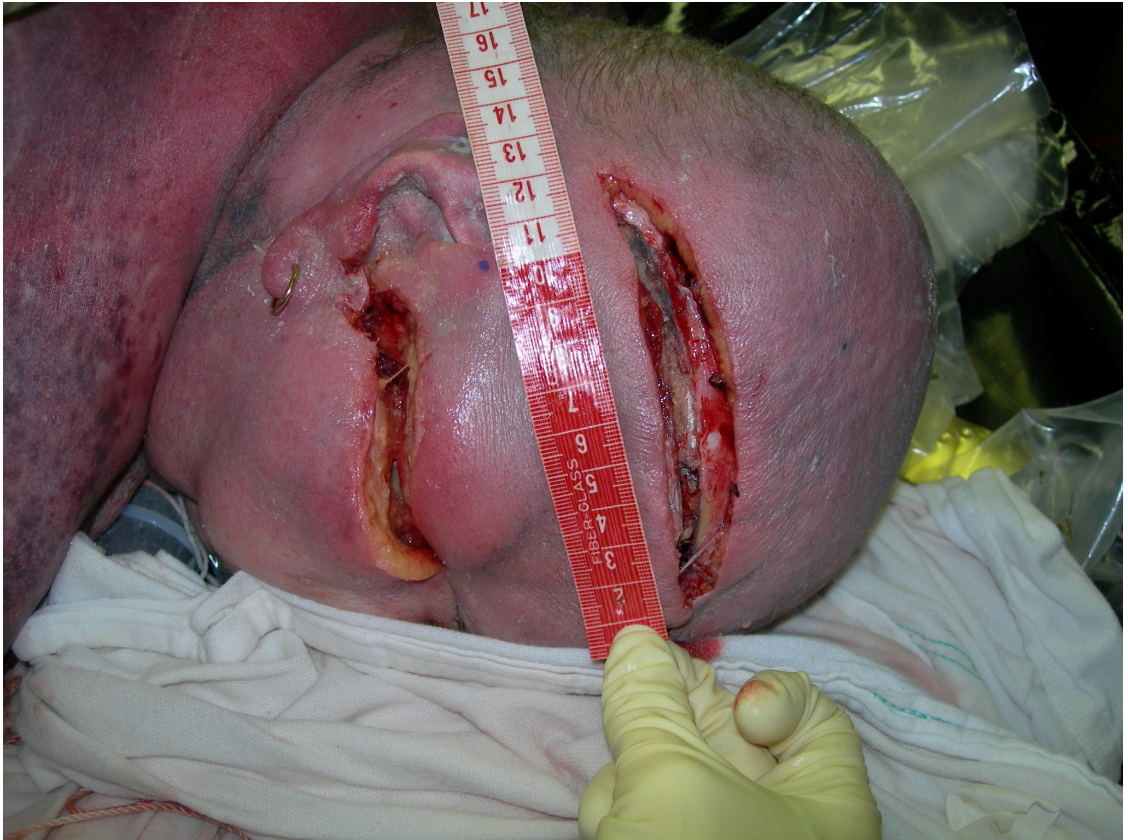
Figure 3.23 Lacerations, fractured zygoma, and comminuted skull fracture from standard propeller blade impacts in human specimen 3 from test 14.H3S7R.

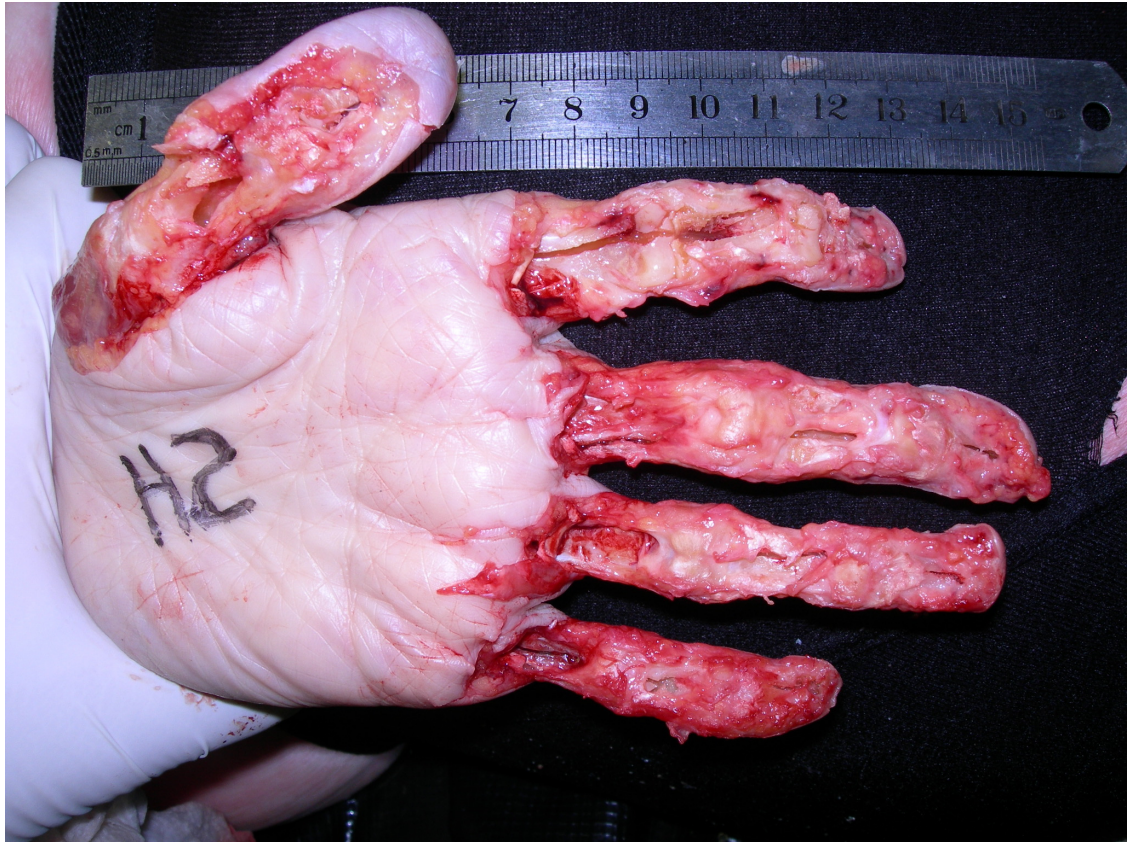
Figure 4.4 Longitudinal fractures of the phalanges in hand two.

The results from the testing indicate that the fracture behavior of phalanges is to fracture in a longitudinal direction, sometime accompanied by a transverse fracture transecting the condylar region of the phalange. All of the phalanges from the first two cadavers tested (hands one – four) fractures, whereas the phalanges from the third cadaver (hands five and six) appeared to be more resistant.

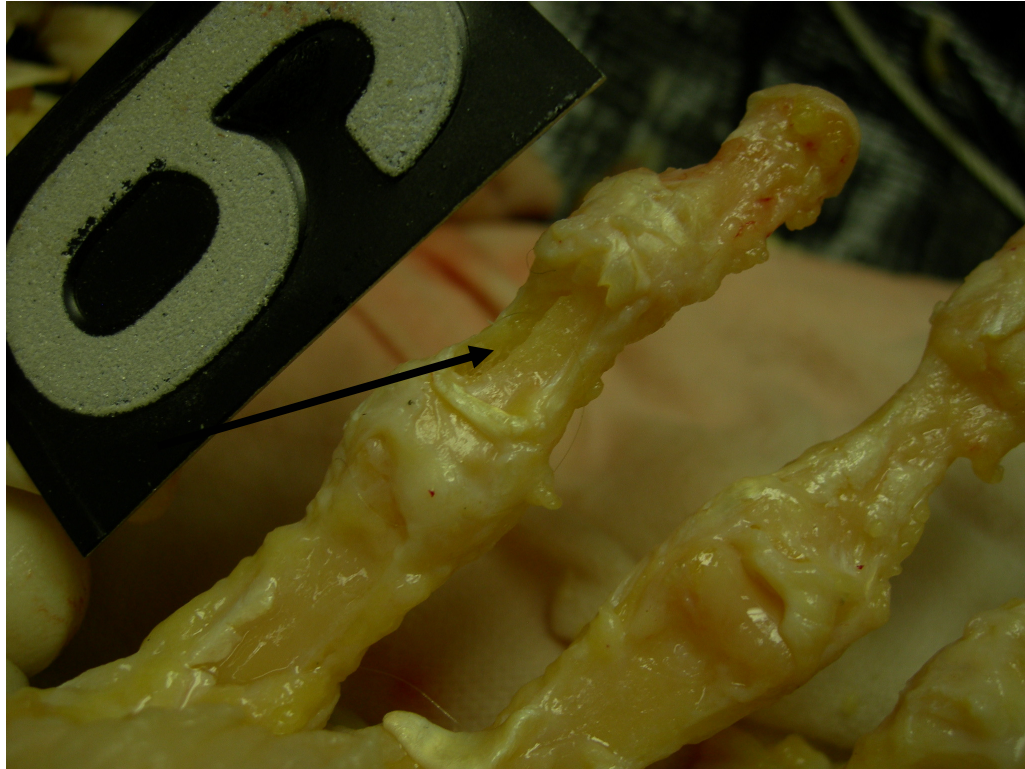
Figure 4.5 Longitudinal fracture to the intermediate phalanx of the fifth ray.

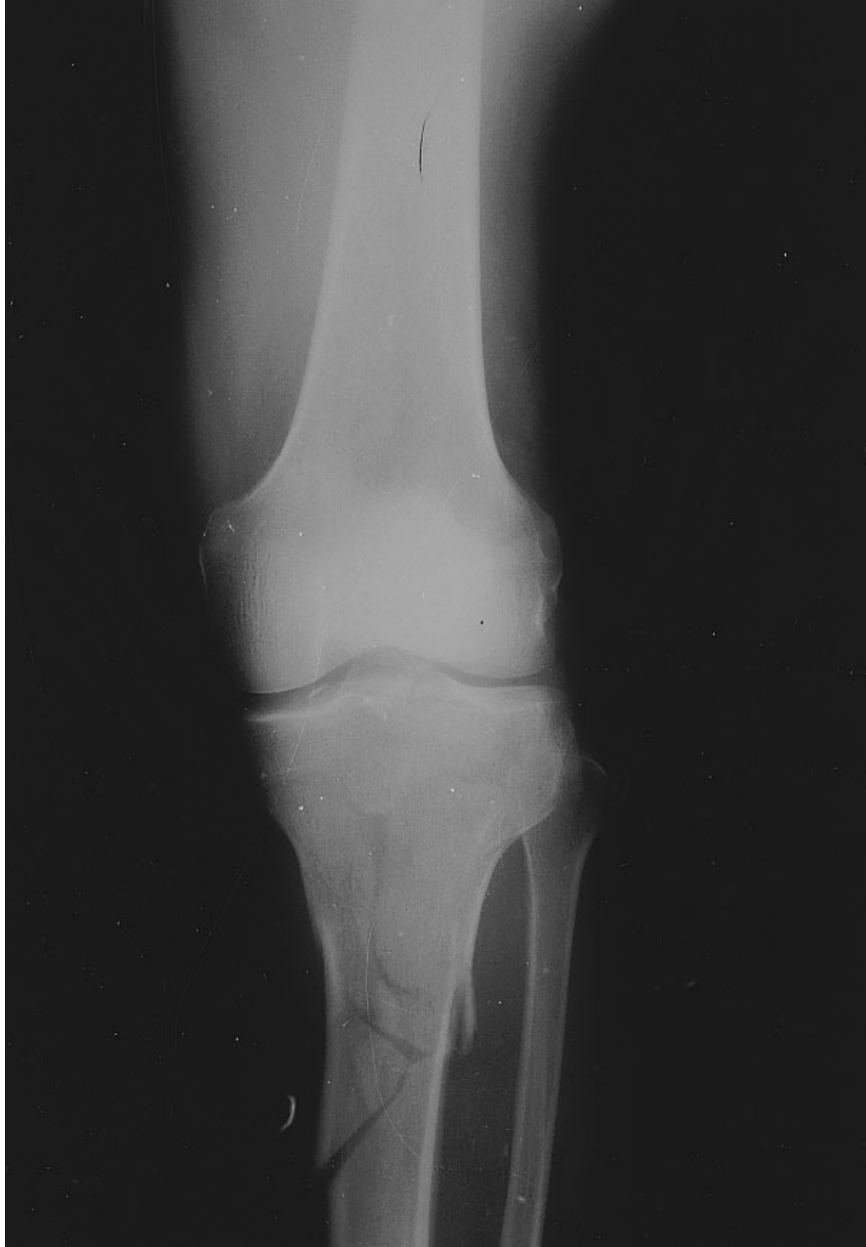
Figure 5.14 Radiograph showing fracture from an axial load.

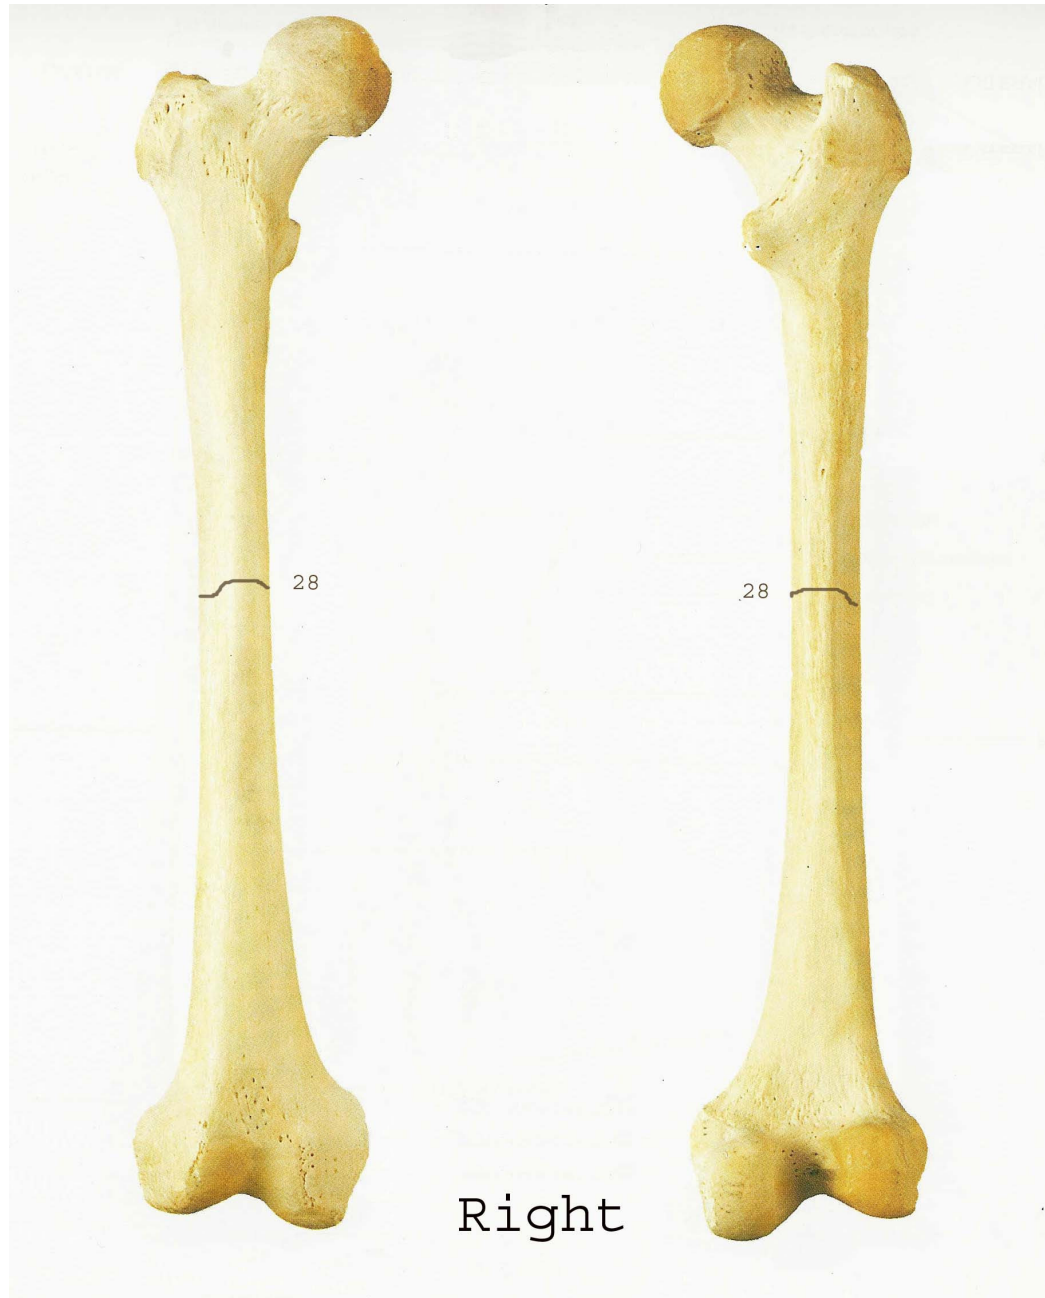
Figure 5.15 Locations of all PWC fractures involving the right femur.

The fractures were all charted on diagrams in order to see if there was any pattern or consistency in the location of the trauma. The majority of the fractures involved the tibia and fibula. There were only two fractures of the femur and two fractures affecting the foot. The location of the fractures from each case were traced on a diagram in their anatomical location. This aided in visualization of the most common fracture patterns (Figures 5.15, 5.16, 5.17, 5.18, and 5.19). The most common skeletal element to be fractured was the fibula (55.6% of fractures), followed by the tibia (40.7%) of the fractures. Fractures to the femur and bones of the foot account for the other 7.4%. The results were also quantified by calculating the rate of fracture for the proximal end, the diaphysis,

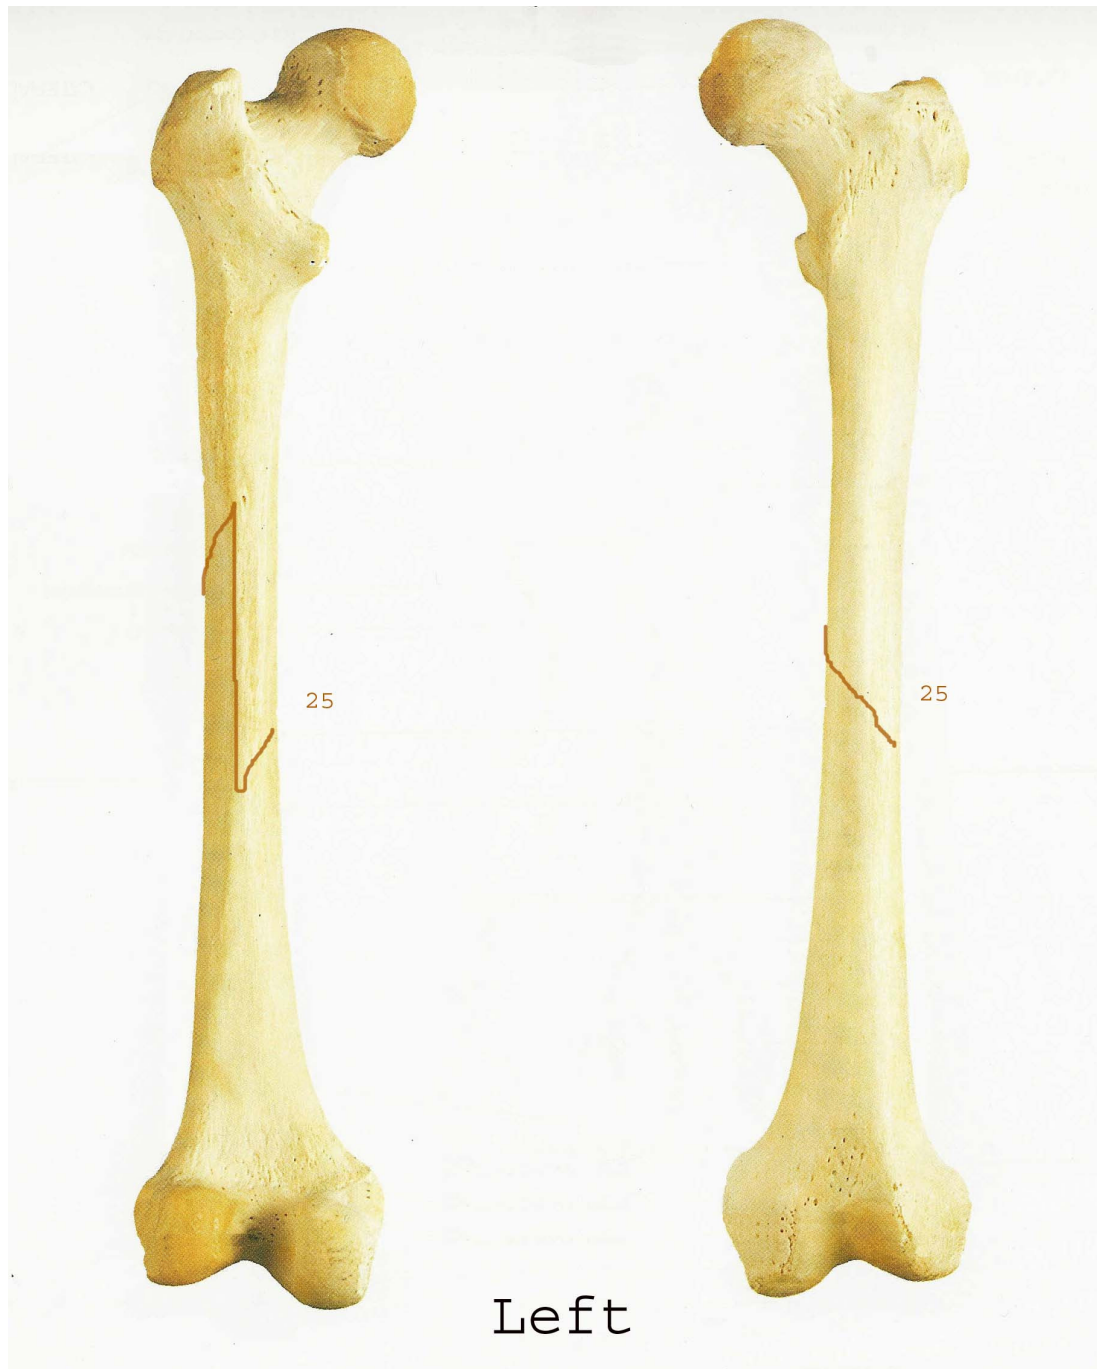
Figure 5.16 Locations of all PWC fractures involving the left femur.

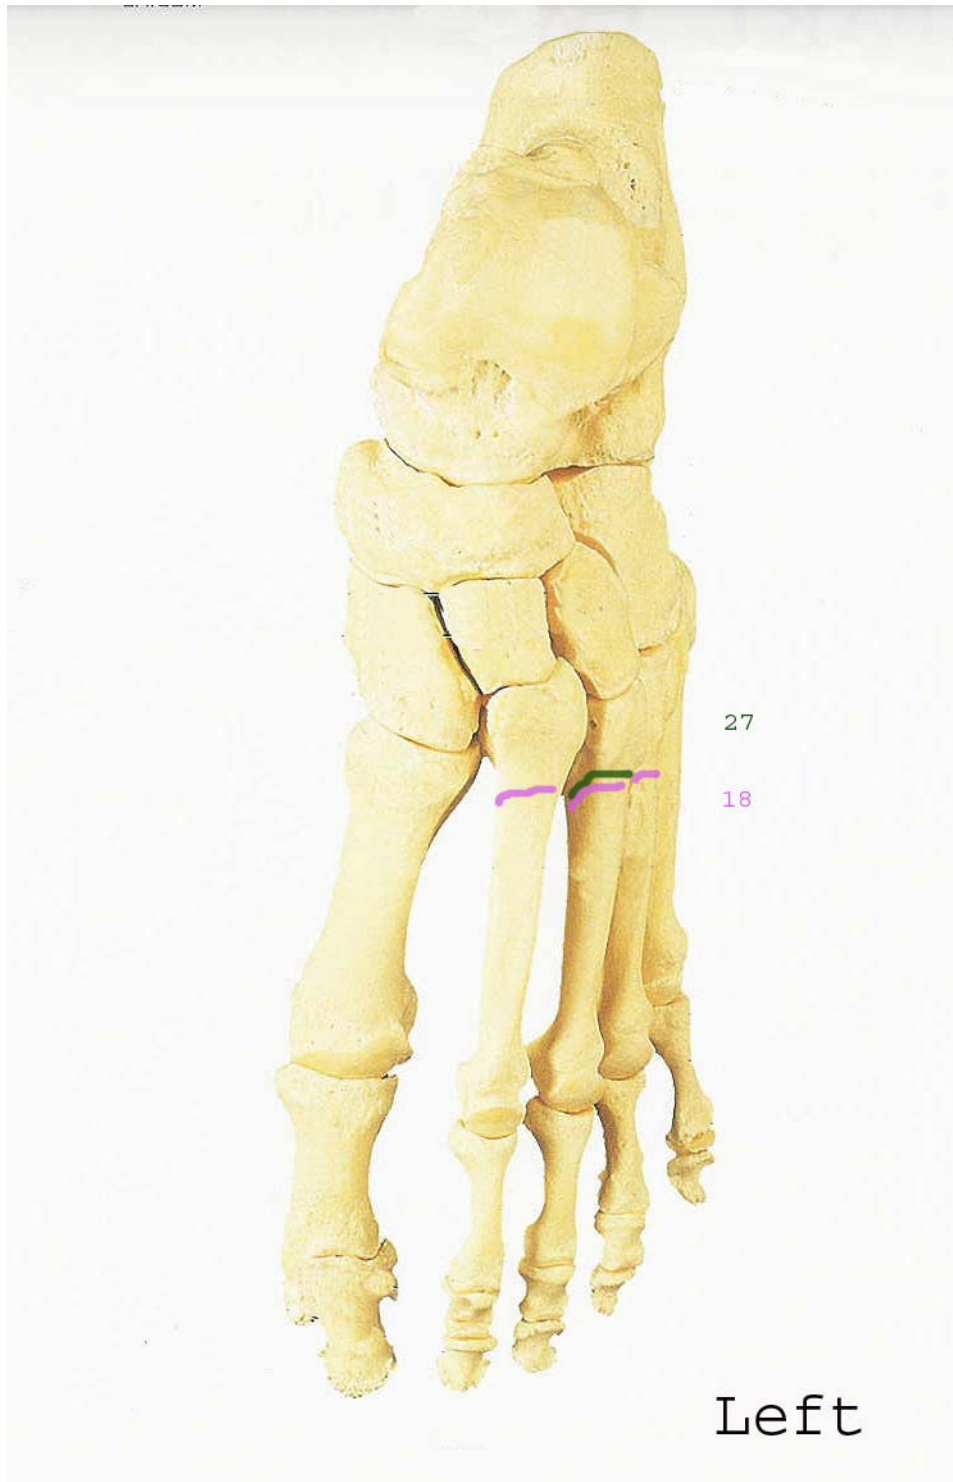
Figure 5.19 Location of all PWC fractures involving the left foot.

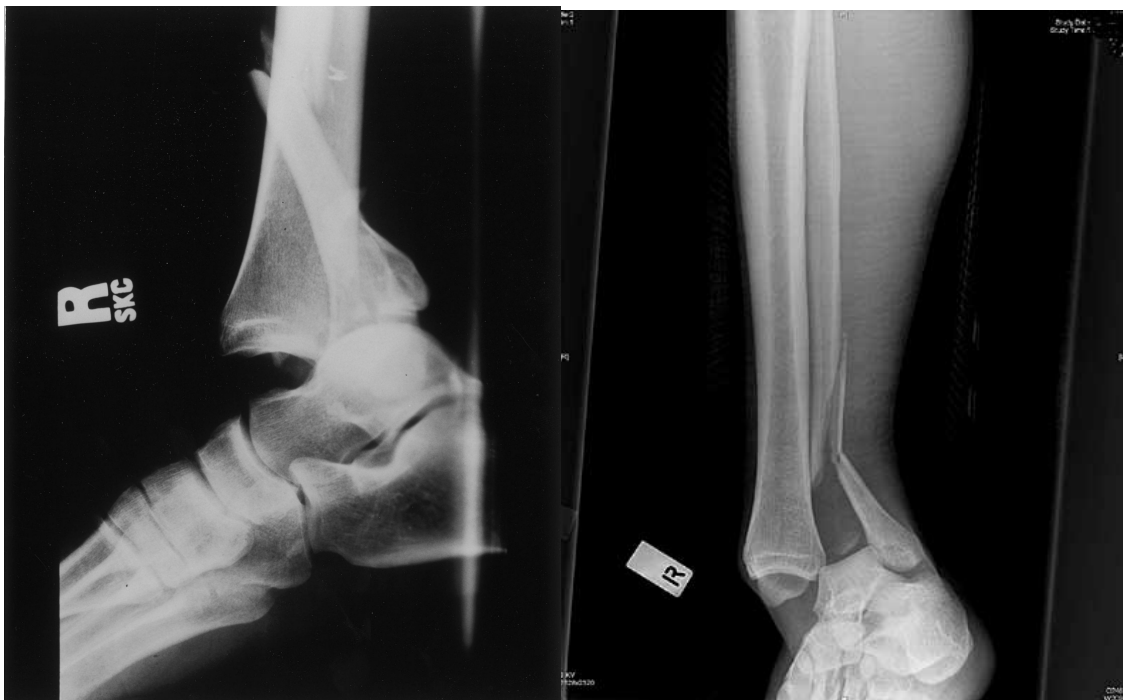
Figure 5.27 Comparison of fracture patterns between PWC case 15 and a slip and fall.

Radiographs for PWC case 15 show extensive fracturing, with a posterior displacement of the talus and anterior displacement of the tibia. Fractures are present on the lateral and medial malleolus, with displacement of the fibular shaft (shown on the left in Figure 5.27). The other radiograph picture in figure 5.27 (shown on the right) is from an individual who slipped on wet grass. The fracture pattern is very similar and there is a similar pattern of displacement. Both of these injuries has a mechanism of external rotation. Again, the similarities between the fracture patterns illustrate that the injuries seen are not unique to the use of personal watercraft and can occur from a variety of everyday activities.

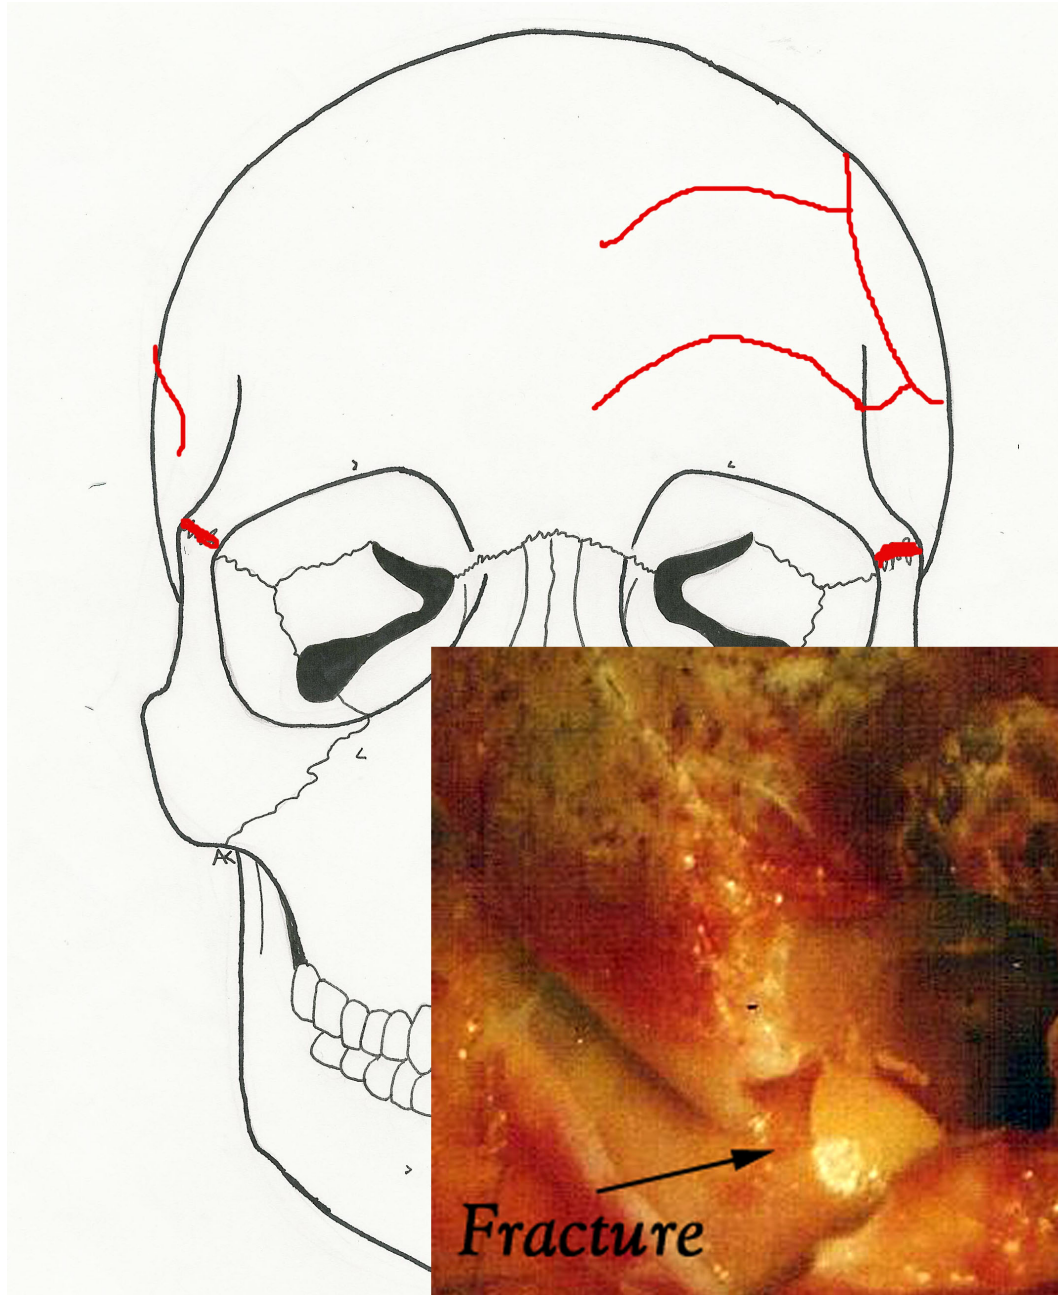
Figure A.9 The frontal view of the skull used in test five and resulting fractures. There were bilateral fracture of both fronto-zygomatic sutures (insert).

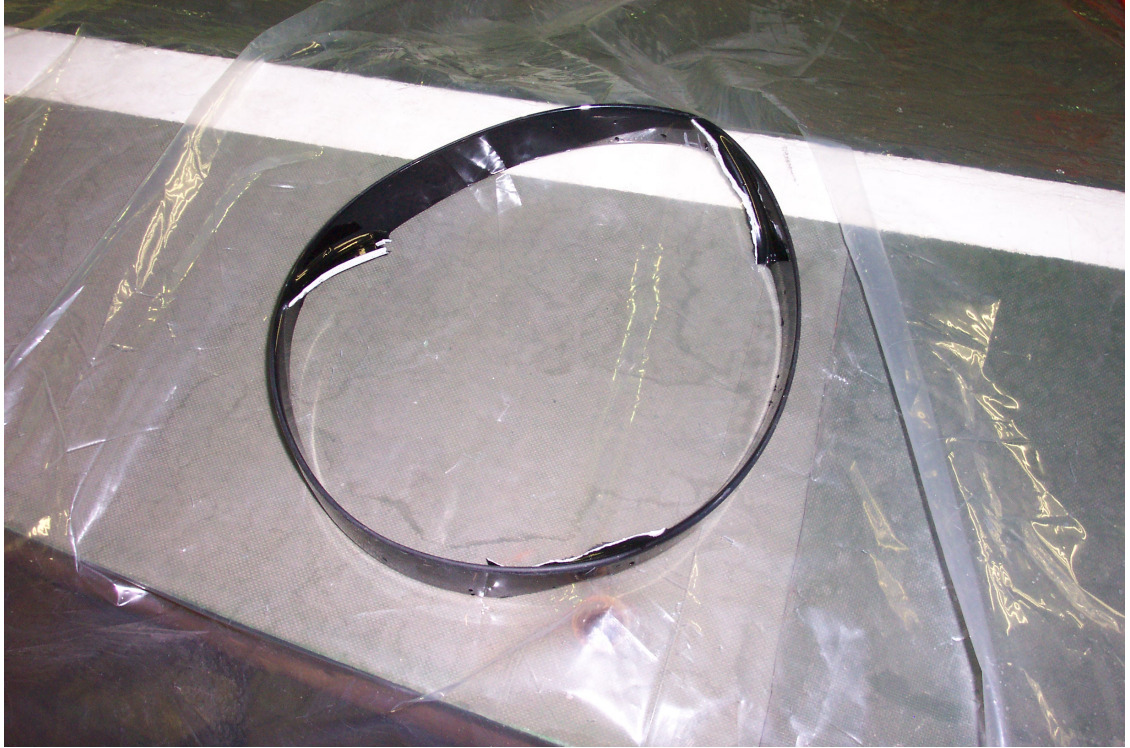
Figure B.5 Broken ring from test five.

In this test, pig three was impacted on the left at an approximate velocity of 15 mph using the RingProp. During the impact, the RingProp broke, with the ring portion coming completely off the three blades (Figure B.5). There was a large laceration to the hindquarters of the pig (Figure B.6), along with a laceration near the orbit. There was an accompanying fracture to the left zygoma (Figure B.7).

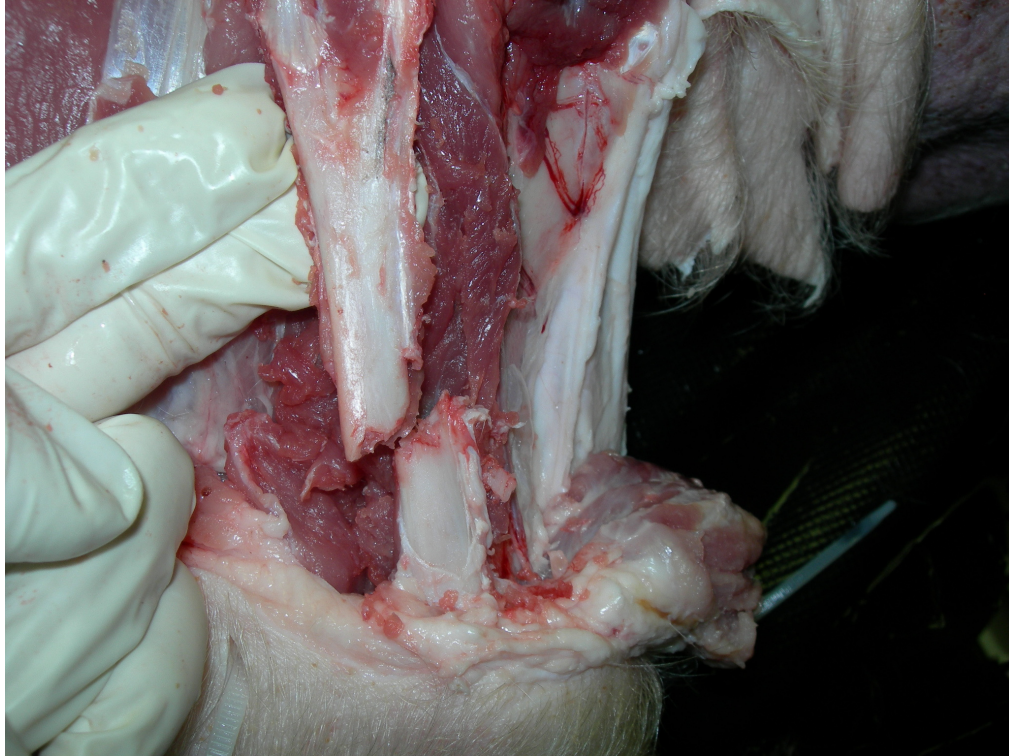
Figure B.13 Fracture of right ulna.

Test seven used porcine specimen four and the RingProp, impacting the pig on the right side at an approximate velocity of 15 mph. The RingProp was replaced after being damaged during test five. The pig was held in position using strings attached to the tail, right ear, and left ear. The injuries to the pig were a very large laceration of the right flank with avulsed muscle tissue (Figure B.11) and a large laceration to the right abdominal area (Figure B.12). A fracture of the right ulna was also present (Figures B.13 and B.14).
